The Restoration of Rotherby Village Pump

Introduction

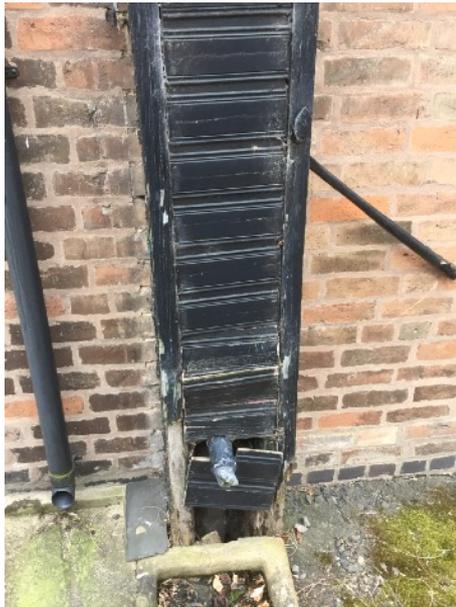
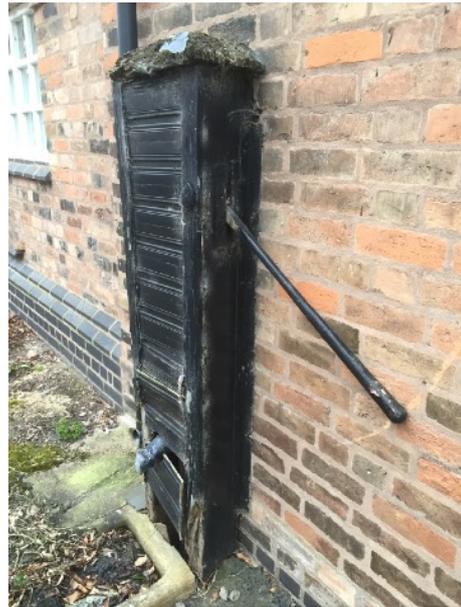
These two pictures illustrate the decline suffered by the pump, including damage from a vehicle colliding with the spout and case. It was decided during the summer of 2016 to restore the pump to at least a visually pleasing look, even if it could not be made to work once more. Following meetings at the Parish Council, a budget was allocated for the works and quotations requested. During September 2016, a contract was awarded to Rotherby craftsman Alan Odom, who had provided the council with a 3D model showing his proposal for the new case as below:

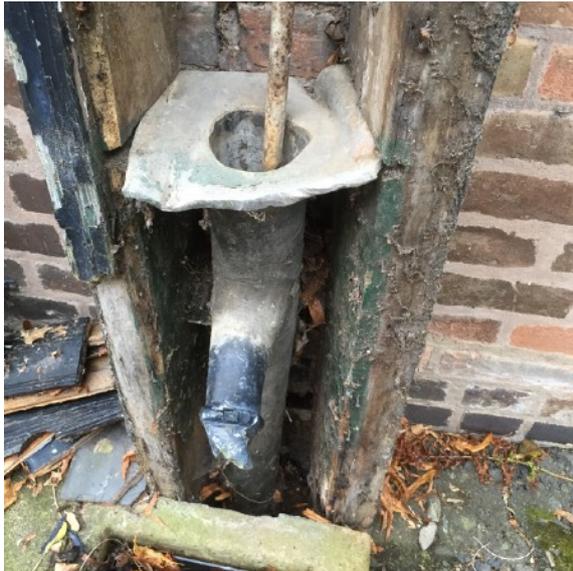
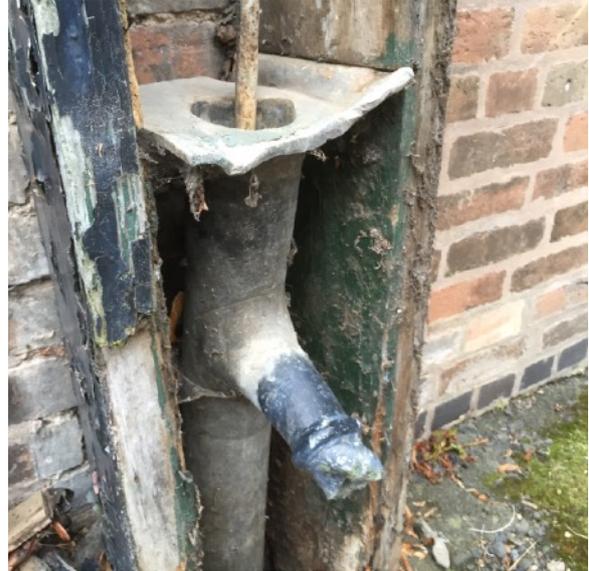
The front panels were removed from the case and the full extent of the damage to the lead pipe and spout became apparent:

Not only was the end of the spout damaged but also the top plate was considerably deformed. In addition, there was black paint on the spout that would need to be removed. The case was then completely removed and the wall behind the pump cleaned with a stiff brush. The trough in front of the pump was also cleaned out, its contents included several bricks and a few years worth of debris.

The first job undertaken was the cleaning and re-shaping of the pump tube and spout. This could not be removed from the ground so the work was done in situ. A blowtorch was used to gently heat the spout end so that it could be straightened out using steel forming tools and a planishing hammer. It was possible to get the spout back to its original shape. Next the top plate was also gently heated and pressed back into shape using steel plates and a “G” clamp. Again it was possible to get the top plate back to its original shape although there remained some surface stress cracks where the lead has been folded particularly tightly. These were repaired using a blowtorch to melt some lead into the cracks.

Next, the black paint was removed using a blowtorch to heat the paint to such a temperature that it could be easily removed with a brass wire brush. This tool was chosen so it did not unduly mark the surface of the lead. Once all the paint was removed the whole pipe and spout was cleaned using a green scouring pad and a commercial kitchen cleaner, with plenty of water. This process took around 3 hours and resulted in a smooth finish.

Once all traces of the cleaner had been removed, the pipe and spout was treated with patination oil to preserve it for the future.

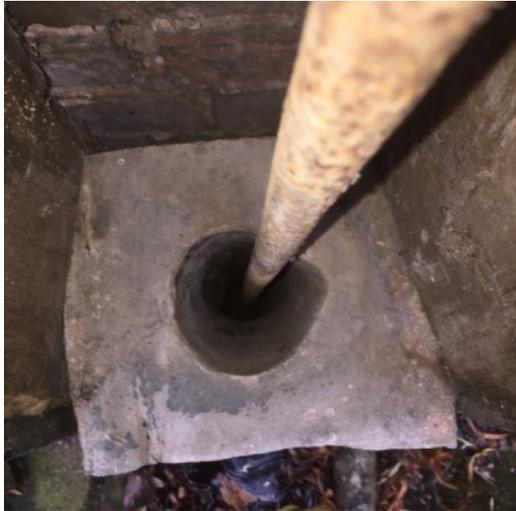
Next the plunger had to be removed. It could not be withdrawn without considerable “persuasion” from a crowbar. This was used mainly to turn the rod as it was slowly withdrawn.

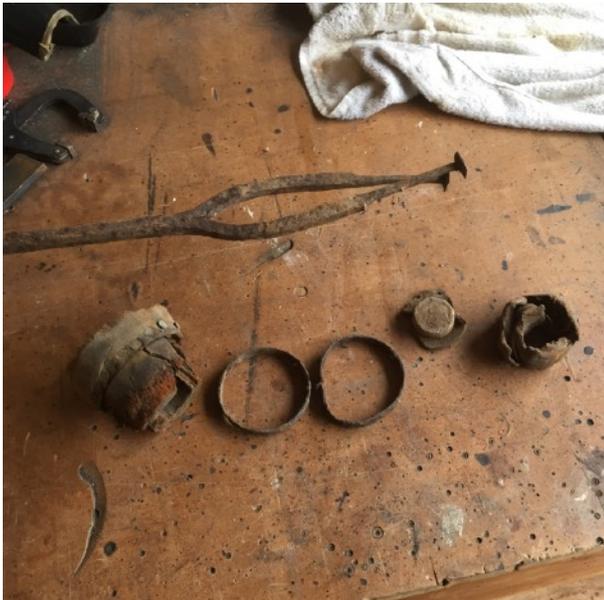
Once out it was discovered that the original “bucket” was broken in half and beyond repair. Also, the leather washer and clacker valve were missing and presumed lost when the pump was put out of service in 1946. However, a little “fishing” around in the pipe, using the rod, produced not only one, but two worn leather washers, the clacker valve and weight and also two iron rings that were presumably used to secure the bucket to the rod, below is a picture of what was removed from the pipe:

Clearly the bucket would need to be replaced and leather would need to be acquired to make the new washer and clacker valve, this would be sourced from a local cobbler.

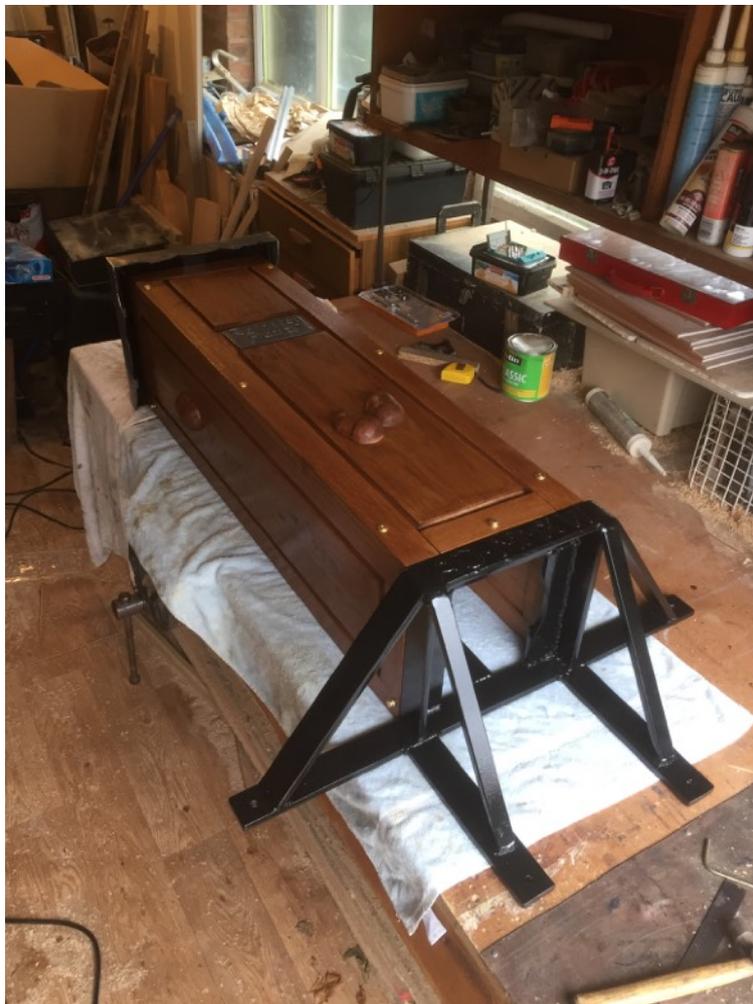
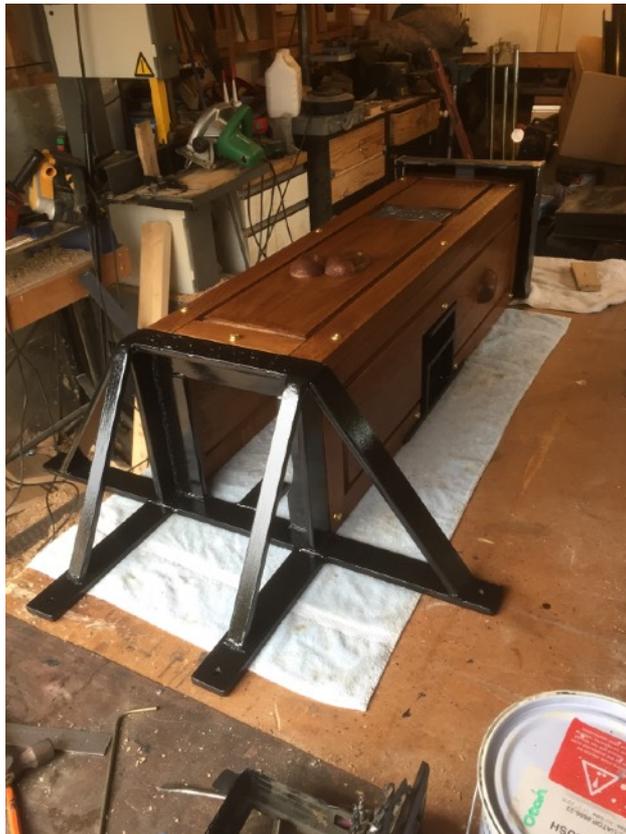
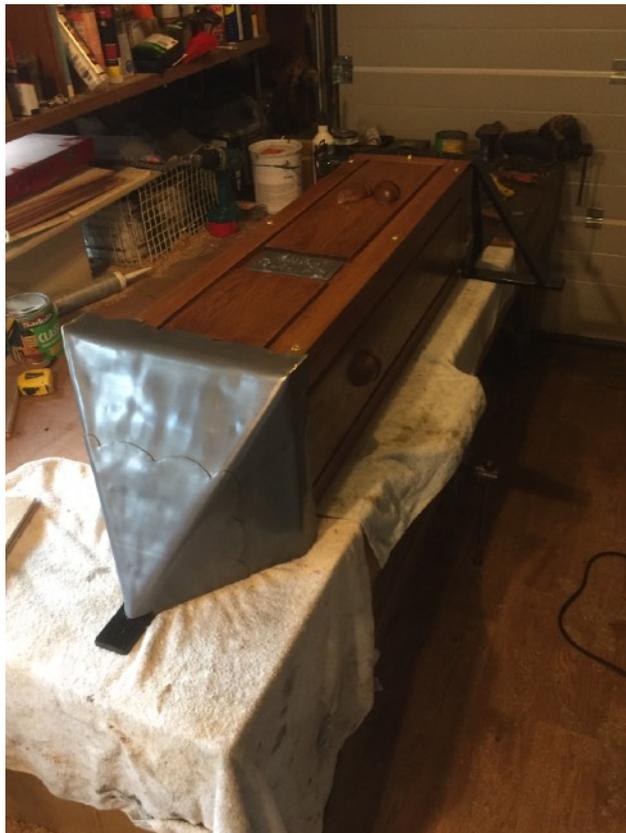
This picture and the two on the next page illustrate the complete assembly during its build phase. The lower bracket has had the letters “AO MMXVI” added on the front, denoting the makers initials and the year of restoration. These were “written” using the MIG welder as a pen.

Above: the pump, minus its handle and workings. The next task is to fit the pump to the wall and test to see if there is any usable water in the well.

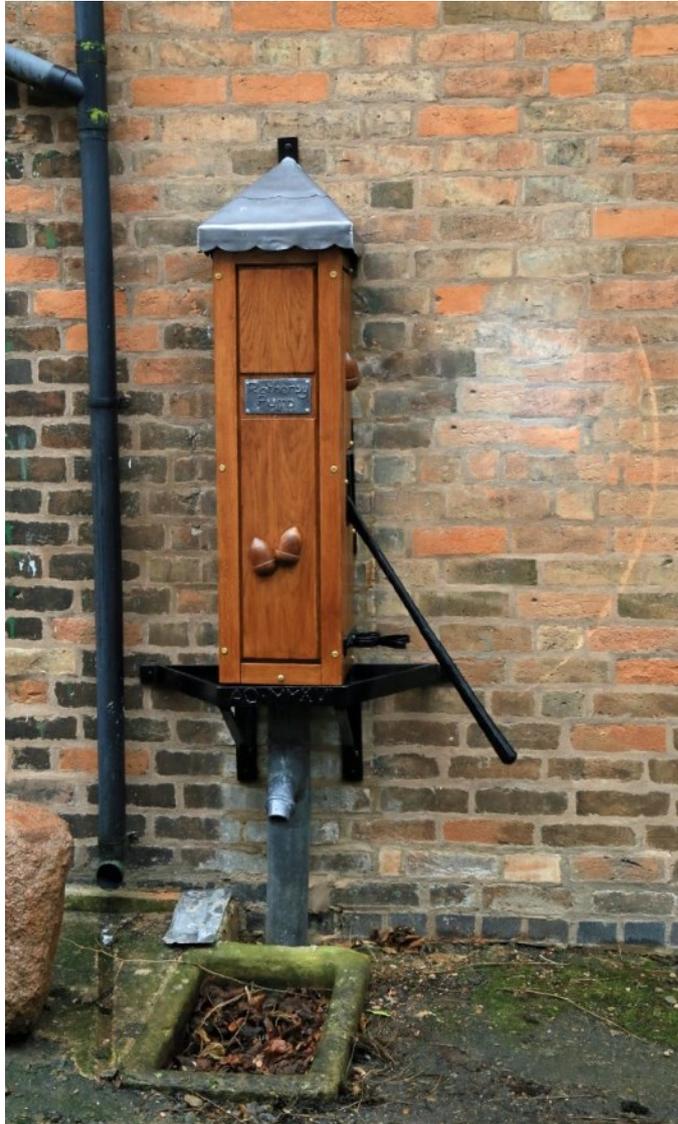
Finally the pump was primed with water using a hosepipe and tested. All the valves worked as expected and water could be heard to move from below to above the plunger. Sadly though after several cycles of the pump handle the pump could be heard to draw air, rather than water from the well below. From this we have concluded that there is no water above the lower end of the pump pipe in the well, so the pump will not draw water from the well at the moment.

We have discovered from other residents of the area that their wells and springs have dried up recently since a gravel quarry was opened a mile or so away. This pit has gone down 40ft into the ground and is being pumped to keep it dry. We have therefore presumed that this operation has lowered the water table. Since the pump last drew water in 1946, land drains have also been installed in the village at the time the mains water supply was added and this may also have effected the water table.

The various metal brackets have been attached to the wall of “Pump Cottage” using expanding bolts. The wooden panels were attached using brass machine screws and cup washers, this is to protect the oak from staining that would occur if steel fastenings had been used.
