The Restoration of a Lift & Force Pump (with update)

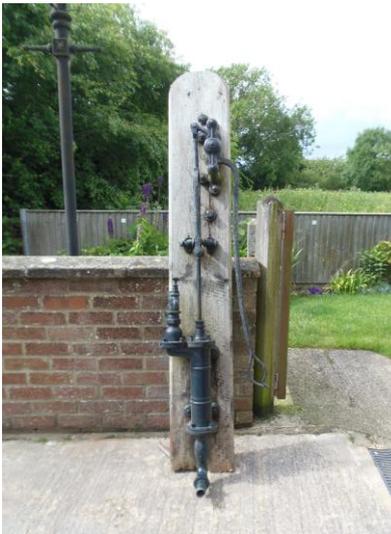
The pump was purchased through e-bay from a vendor in Great Yarmouth who had some 20 years ago rescued it from a skip, no less, when working for a water company. He had kept it as a 'garden feature' since then after dousing in several layers of black paint! To demonstrate its authenticity prior to placing online for sale the vendor had scratched some of the paint off the barrel to prove it was made of brass. No maker or founder mark is in evidence so presently there is no clue to its provenance.

Pump as purchased

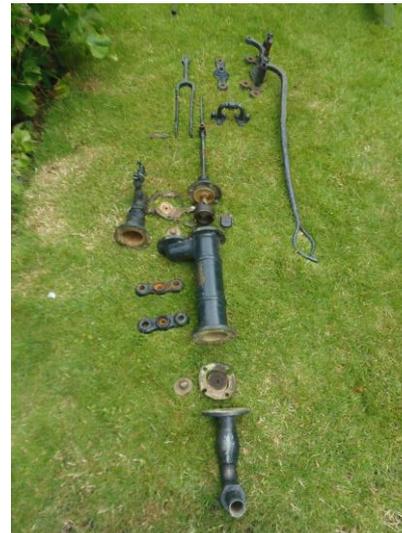
Pump dismantled

I set about dismantling the pump which fortunately was relatively easy given that brass nuts were placed on steel studs of the fulcrum plate and the cast iron brackets which hold the brass barrel in place were fixed with steel bolts. So generally there were no common metal fixings that can cause problems with dismantling. Such instances are steel against steel or steel with cast iron, like in the case of the steel clevis pin connecting the bow with the bearing on the operating rod. Removal necessitated the use of graphite-based easing oil, the judicious use of a hammer and elbow grease. Brass against brass as in two bolt fixture for plunger clack valve caused a bit of a headache as both sheared off during dismantling!

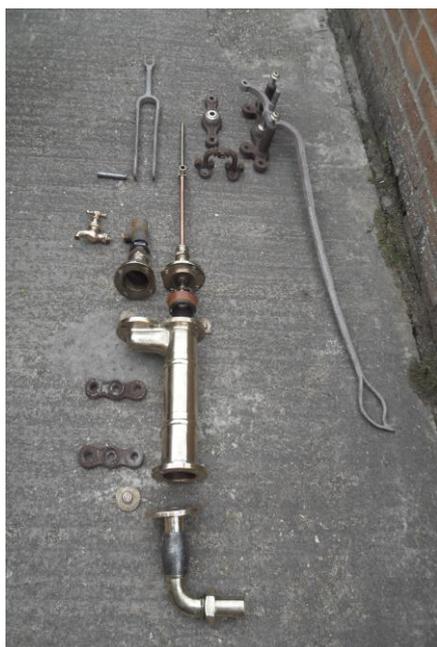
Sandblasted & polished parts

All the cast iron components such as the pump handle, fulcrum plate and housing, the bow, the operating rod guide and the two brackets for mounting the barrel were sandblasted by a friendly local blacksmith for the princely sum of three bottles of wine! All the painted components were stripped using the widely available NitroMors and, again, much elbow grease! This revealed some very nice joint work fashioned in lead, where the brass inlet pipe is fixed to the bottom plate of the barrel and where the outlet and 1/2" brass tap were fitted to the hold-up/retaining valve housing. This type of work is reminiscent of the days when this was done by telephone engineers on underground cables via manholes in the pavement.

Polishing was done on a temporary modified 6" electric grinder with a succession of 6" sisal, stitch and soft cotton mops, i.e. from coarse abrasion then soft with the application of metal polishing wax compound, first course then finer grit. Afterwards a nice sheen was obtained with the aid of 6" Scotch Brite discs in descending order of grit.

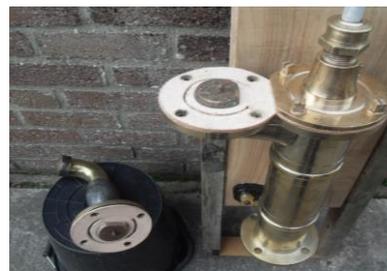
Leather clack valves

All clack valves flexible materials had deteriorated and needed to be replaced. These were fashioned from 4 mm leather for the bottom gasket/clack valve, the top of the barrel gasket/hold-up housing/clack valve and 4mm silicone rubber for the plunger clack valve. I found 4 mm leather for clack valve in the last-named location was, owing to its relatively small size, very inflexible. The original material was 4 mm butyl rubber and this gave a clue that leather might not be entirely suitable. It was replaced by blue 4mm silicone rubber. The two $\frac{5}{16}$ " BSW cheesehead slotted brass bolts retaining the plunger clack valve, which sheered-off during dismantling, were re-bored and tapped. The replacement bolts were of the stronger slotted round headed variety to assist with future replacement of the silicone rubber clack. Each of these bolts were further held in place with hexagon brass lock nuts.

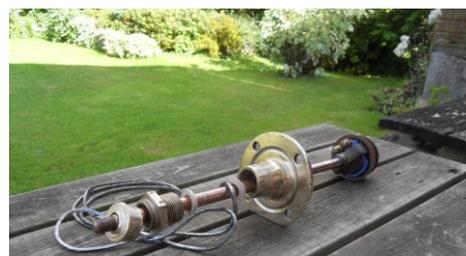
Stuffing box & plunger assembly

The stuffing box was packed 5mm square graphite gland rope with washers top and bottom to replace the originals and cut from 4 mm leather.

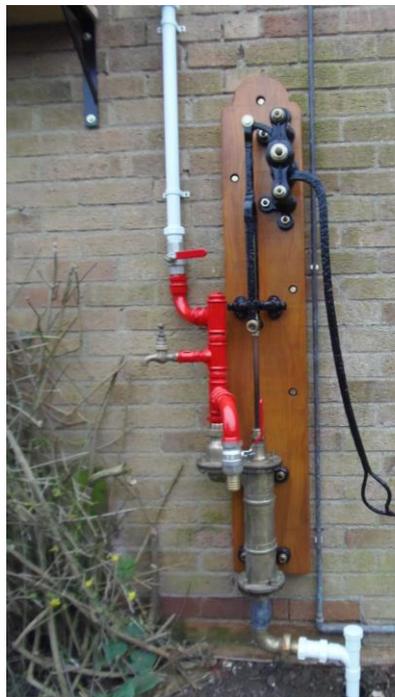
Pump & Header Tank

By the use of two ball valves (red handles in photos below) the water from the pump can be pumped directly into a pail via the spout, or fed into an 85 l PVC header tank from which water can be drawn off via the spout or the $\frac{1}{2}$ " brass tap which

came with the pump. Overflow, from the storage tank feeds by gravity into a 210 l water butt. This well water is much infinitely cleaner than the rainwater hitherto fed into the butt which was derived from the lee side of the house and always became contaminated with moss. It was not at all good to use for the watering salad crops.....it had a long-lasting strong odour to say the least! I found it advisable to turn off the top ball valve when the system was not in use otherwise the hydrostatic pressure created by the water in the header tank created a bit of a challenge for the pump stuffing box.

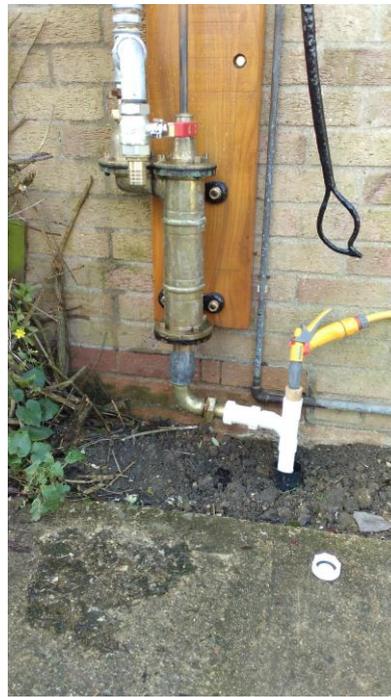
Priming the barrel

The pump was fitted to an outside wall adjacent to the well and plumbed in using $1\frac{1}{4}$ " BSP galvanized steel fittings and widely available McAlpine PVC waste water fittings. The intake in the well incorporated a non-return (check) valve and an access plug just above the ground to assist in draining the pump during a severe freeze-up. This access plug has proved a blessing in disguise as it also facilitated priming the barrel in the event of this being necessary. This was achieved by use of a garden hose pipe with the Hoselock jet fitted and this held in place with a suitable size cork with a centre bore. This procedure in a few words is like providing the pump with an enema!
