The Restoration of a Lift & Force Pump

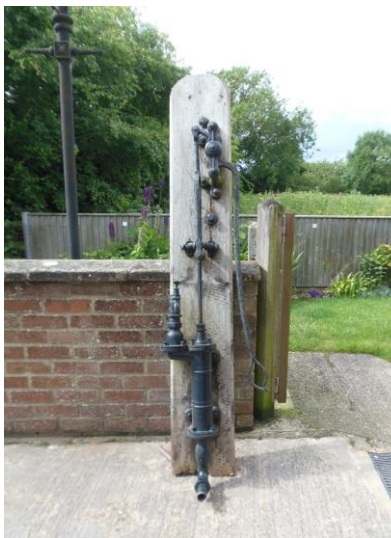
The pump was purchased through e-bay from a vendor in Great Yarmouth who had some 20 years ago rescued it from a skip, no less, when working for a water company. He had kept it as a 'garden feature' since then after dousing in several layers of black paint! To demonstrate its authenticity prior to placing online for sale the vendor had scratched some of the paint off the barrel to prove it was made of brass. No maker or founder mark is in evidence so presently there is no clue to its provenance.

Pump as purchased

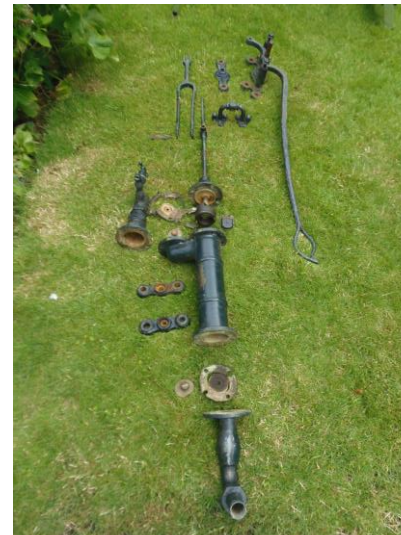
Pump dismantled

I set about dismantling the pump which fortunately was relatively easy given that brass nuts were placed on steel studs of the fulcrum plate and the cast iron brackets which hold the brass barrel in place were fixed with steel bolts. So generally there were no common metal fixings that can cause problems with dismantling. Such instances are steel against steel or steel with cast iron, like in the case of the steel clevis pin connecting the bow with the bearing on the operating rod. Removal necessitated the use of graphite-based easing oil, the judicious use of a hammer and elbow grease. Brass against brass as in the two bolt fixture for the plunger clack valve caused a bit of a headache as both sheared off during dismantling!

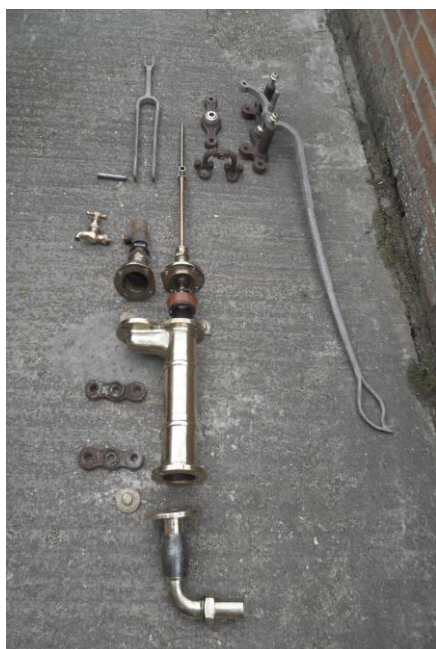
Sandblasted & polished parts

All the cast iron components such as the pump handle, fulcrum plate and housing, the bow, the operating rod guide and the two brackets for mounting the barrel were sandblasted by a friendly local blacksmith for the princely sum of three bottles of wine! All the painted components were stripped using the widely available NitroMors and, again, much elbow grease! This revealed some very nice joint work fashioned in lead, where the brass inlet pipe is fixed to the bottom plate of the barrel and where the outlet and 1/2" brass tap were fitted to the hold-up/retaining valve housing. This type of work is reminiscent of the days when this was done by telephone engineers on underground cables via manholes in the pavement.

Polishing was done on a temporary modified 6" electric grinder with a succession of 6" sisal, stitch and soft cotton mops, i.e. from coarse abrasion then soft with the application of metal polishing wax compound, first coarse then finer grit. Afterwards a nice sheen was obtained with the aid of 6" Scotch Brite discs in descending order of grit.

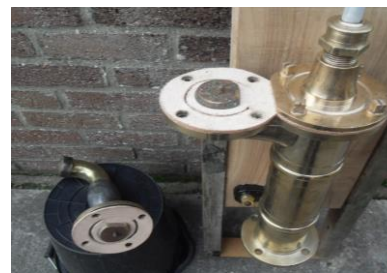
Leather clack valves

All clack valve flexible materials had deteriorated and needed to be replaced. These were fashioned from 4 mm leather for the bottom gasket/clack valve, the top of the barrel gasket/hold-up housing/clack valve and 4mm silicone rubber for the plunger clack valve. I found 4 mm leather for the clack valve in the last-named location was, owing to its relatively small size, very inflexible. The original material was 4 mm butyl rubber and this gave a clue that leather might not be entirely suitable. It was replaced by blue 4mm silicone rubber. The two $\frac{5}{16}$ " BSW cheesehead slotted brass bolts retaining the plunger clack valve, which sheered-off during dismantling, were re-bored and tapped. The replacement bolts were of the stronger slotted round headed variety to assist with future replacement of the silicone rubber clack. Each of these bolts were further held in place with hexagon brass lock nuts.

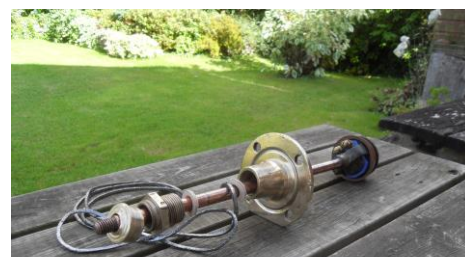
Stuffing box & plunger assembly

The stuffing box was packed with 5mm square graphite gland rope with washers top and bottom to replace the originals and cut from 4 mm leather.

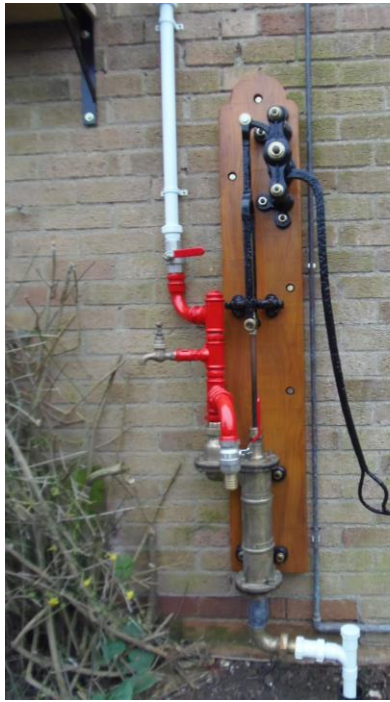
Pump & Header Tank

By the use of two ball valves (red handles in photos below) the water from the pump can be pumped directly into a pail via the spout, or fed into an 85 l PVC header tank from which water can be drawn off via the spout or the $\frac{1}{2}$ " brass tap which

came with the pump. Overflow from the storage tank feeds by gravity into a 210 l water butt. This well water is infinitely cleaner than the rainwater hitherto fed into the butt which was derived from the lee side of the house and always became contaminated with moss. It was not at all good to use for the watering of salad crops...it had a long-lasting strong odour to say the least! I found it advisable to turn off the top ball valve when the system was not in use otherwise the hydrostatic pressure created by the water in the header tank created a bit of a challenge for the pump stuffing box.

Please note much of the initial sheen on the brass and bronze was lost when chromium sulphate used in the tanning of the leather leached out, ably aided and assisted by scale from hard water! Next spring the brass components will be re-polished *in situ* and treated with metal lacquer.

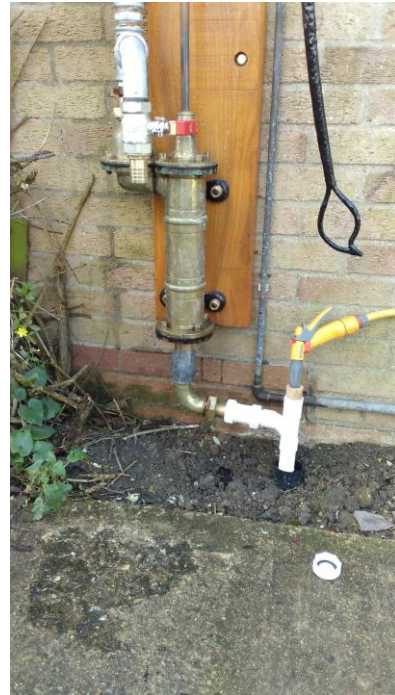
Priming the barrel

The pump was fitted to an outside wall adjacent to the well and plumbed in using $1\frac{1}{4}$ " BSP galvanized steel fittings and widely available McAlpine PVC waste water fittings. The intake in the well incorporated a non-return (check) valve and an access plug just above the ground to assist in draining the pump during a severe freeze-up. This access plug has proved a blessing in disguise as it also facilitated priming the barrel in the event of this being necessary. This was achieved by use of a garden hose pipe with the Hoselock jet fitted and this held in place with a suitable size cork with a centre bore. This procedure in a few words is like providing the pump with an enema!
