## Restoring a hand pump

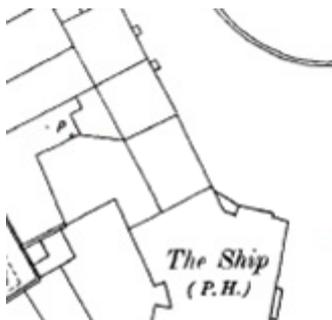
Zooming in to the cottage shows the pump was located just a foot or so to the West of the Northern-most part of the garden wall to the pub (denoted by the 'P' symbol). The eagle-eyed will also spot no fewer than 8 wells (marked 'W') on the map along with another pump in the yard to the rear of the Ship Inn. At this point, we had pinpointed the location of the original pump that served

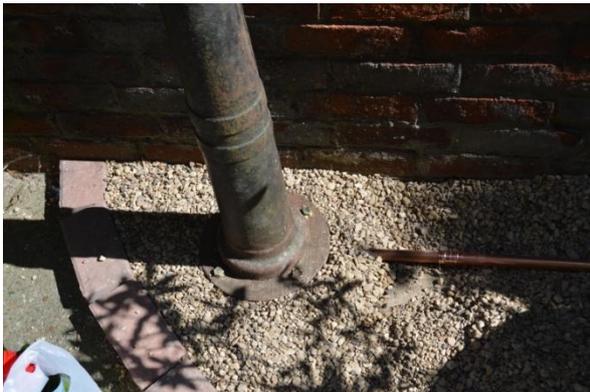
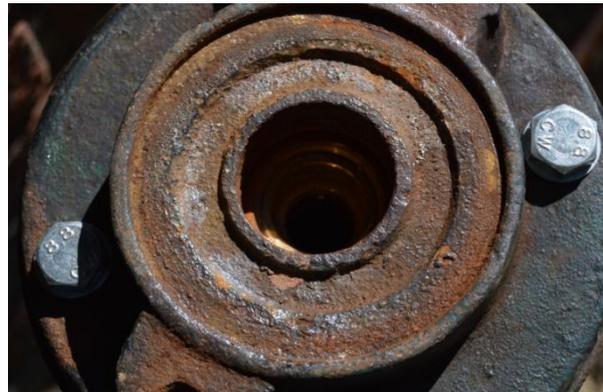
The starting point was to strip the pump down and see what we had. The bore was corroded, but not too badly, the operating rod was present and the rubber washers between the cap and body, and the body and spout were in reasonable condition, but the bottom valve and bucket were missing. I had expected the bolts to be imperial sizes, but oddly the flange bolts and the bolts holding the barrel to the base were 17mm AF, or M10. I suspect that someone had attempted a restoration at some time in the past, as the two bolts holding the spout to the barrel are a slightly smaller imperial size. Unfortunately, the two bolts holding the barrel to the base sheared, despite copious amounts of dismantling lubricant and plenty of heat. The remains of the bolts were cut off flush with a hacksaw before being drilled out and re-tapped, with the help of my son, Karl.

The pedestal was bolted down with spacers to allow the pipework to exit above ground and the base fitted with a new  $1\frac{1}{8}$ " to 22mm adapter. The threads were quite badly corroded and had to be partially re-tapped.

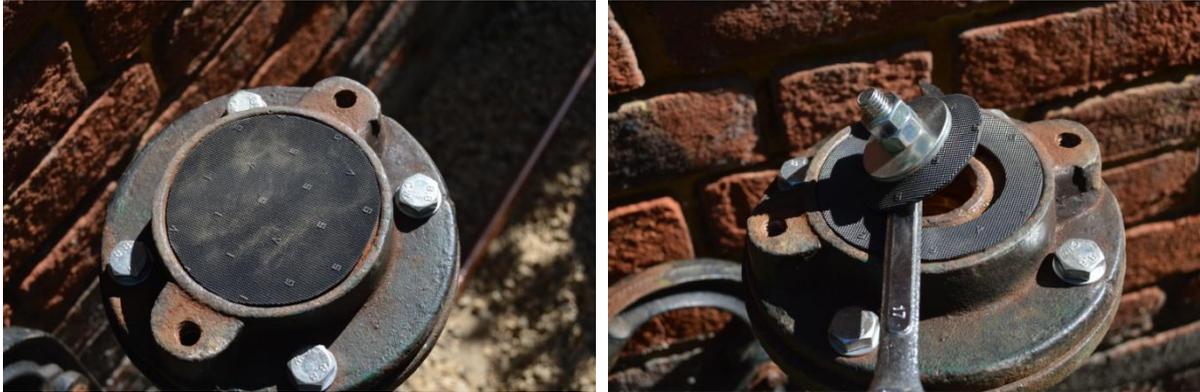
I originally intended to use a piece of leather to fabricate the inlet valve, but a trip to a local cobbler saw me coming home with a piece of rubber shoe sole, as he believed it would be more durable and easier to work with. The rubber was about 1.5mm thick and could be cut with scissors, making it very easy to work with.

A blank disc was first cut out and test fitted, and then a hole punched through the centre, a 'C' shaped cut made with scissors and two large penny washers and an M10 bolt attached. An unintended, but fortunate, consequence of tightening the bolt was to make the whole assembly slightly dished which I hope will help it seal better to the base.

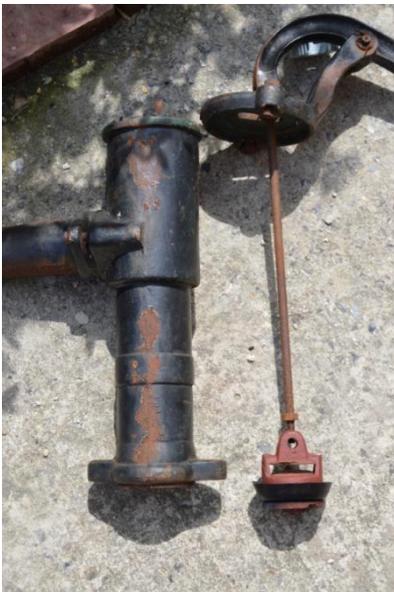
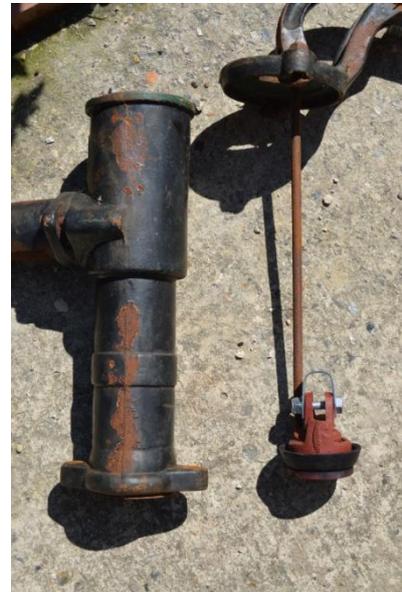
Having ordered a new bucket/valve from Robinson & Sons, it was obvious that the operating rod (also threaded to M10 x 1.5) was too long for the barrel, and we would have to fabricate a new linkage in any event. A yoke was made up from flat steel strip with a hole at the top for the operating

rod. The rod was measured up and shortened with a hacksaw, with the intention of simply re-threading the end with an M10 die. Again, there were problems; the rod was not 10mm, or anything close, and it was proving impossible to get the die started. Without access to a lathe to turn the rod down to the correct diameter, I first re-threaded it with an oversize imperial die, and then recut the threads to

M10 before fitting the yoke with a Nyloc nut and connecting the bucket/valve. The barrel was cleaned with a 40 grit flap wheel sander, followed by an 80 grit one to remove the rust, and while not perfect, the resulting surface seemed smooth enough to be usable. The leather washer on the bucket had been soaked for 5 days to help soften it, but was still a very tight fit, and the whole assembly had to be driven into the barrel with a drift and a lump hammer, before the cap was attached and the operating rod reconnected to the handle.

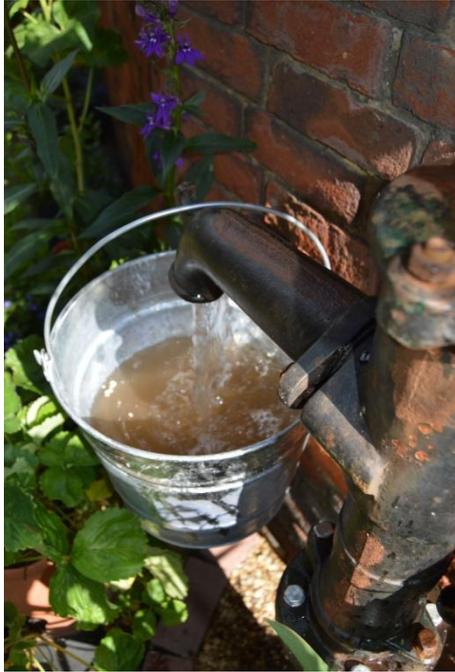
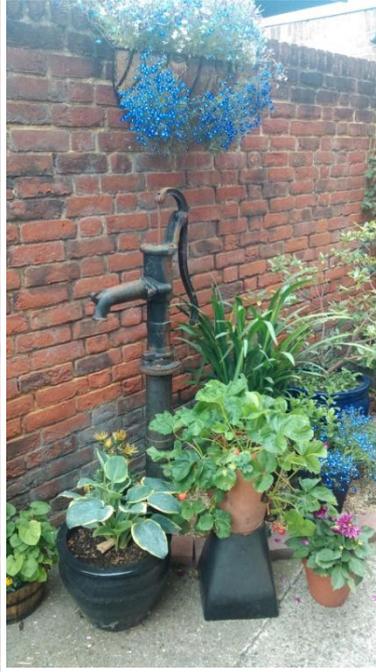
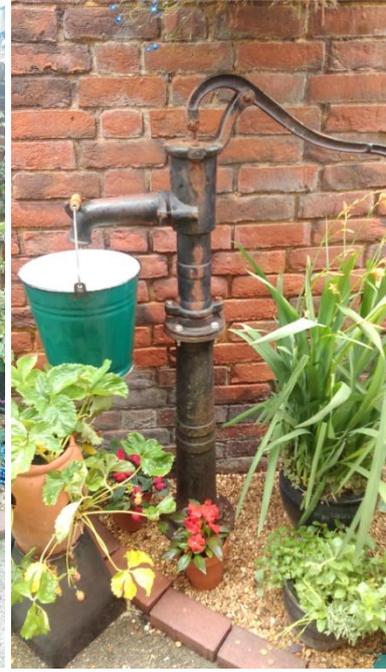
My son Karl had spent some hours with an electric breaker channeling the concrete to take the 22mm feed pipe, and this was then laid in and soldered up, with a compression fitting under the pedestal for easy removal if needed. Two 100 litre rain butts were installed and connected to the downpipe, and flexible hoses run to a simple manifold connected to the 22mm feed pipe. The butts were partially filled, the pump primed, and on the third pump started pumping water. The final touch was to find a (not quite period) 90 year old enamelled bucket in a local antique shop.
