The Restoration of Rotherby Village Pump

Introduction

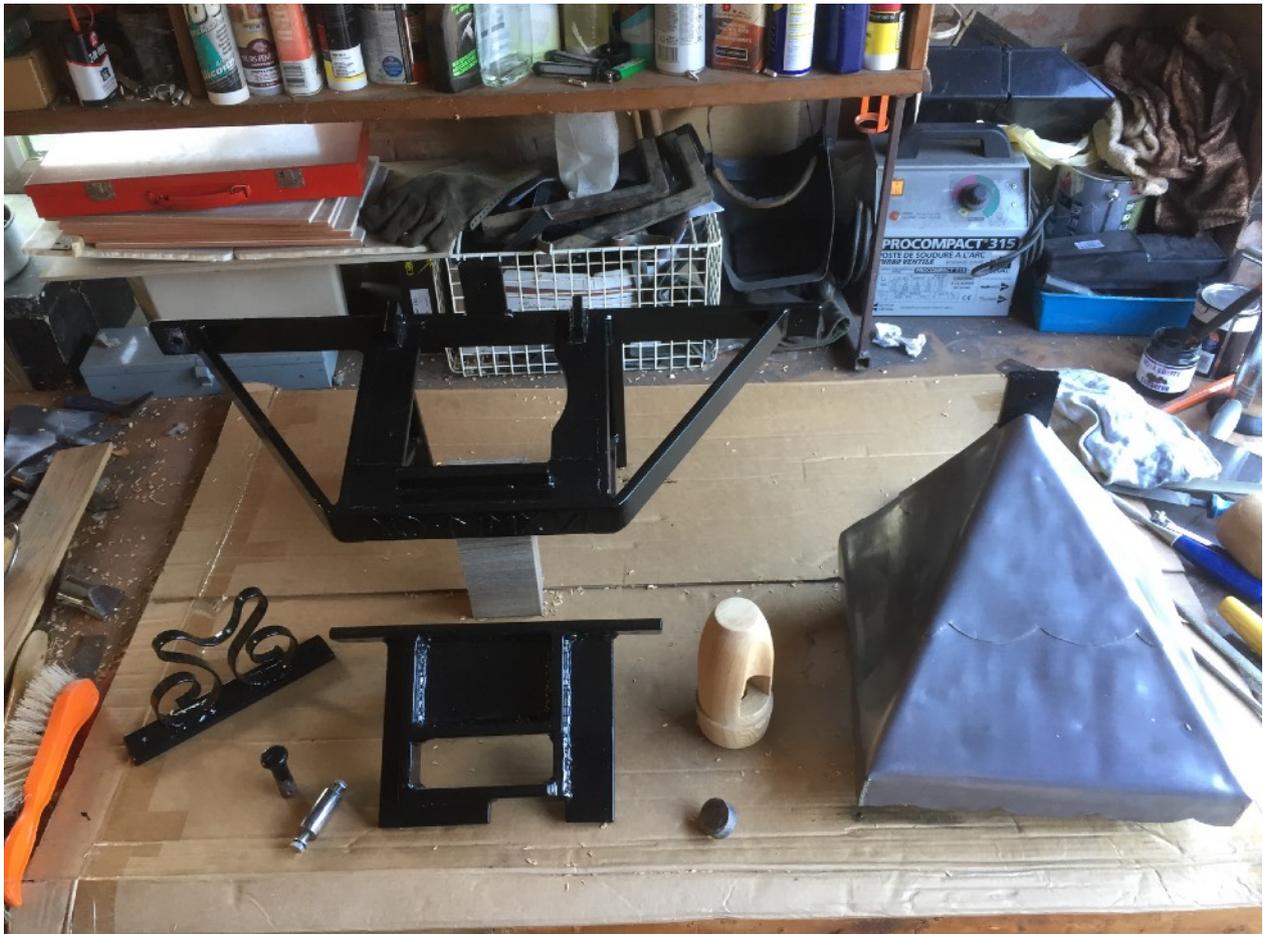
The next part of the project was fabrication of the new steelwork. The main purpose of the bracket at the bottom of the case is to prevent any further damage to the pipe and spout by passing traffic, its secondary purpose is to support the new case. This bracket is made from 50mm x 12mm and 25mm x 12mm solid steel bar welded together using full penetration welds applied with a MIG welder. A new bracket was also made to hold the pump handle, this bracket was again made from 50mm x 12mm, 25mm x 12mm solid and 3mm plate steel. A roof structure was also made from the same materials, this was then covered with lead. The lead was formed around the steel structure and soldered in place using a blowtorch as the heat source, flux and off-cuts of lead as the “filler”. Great care had to be taken here as too little heat will not get a good joint and too much will result in the whole lot melting.

Finally a bracket was made to stop the handle banging in to the case and a new bucket was turned on the wood lathe, then finished by hand, to take the clacker valve and sealing washer. The steel work was painted using specialist metal paint, three coats of gloss finish in black. The lead roof was treated with patination oil to preserve and colour it. The existing handle and rod were cleaned of all rust and painted with the same specialist metal paint.

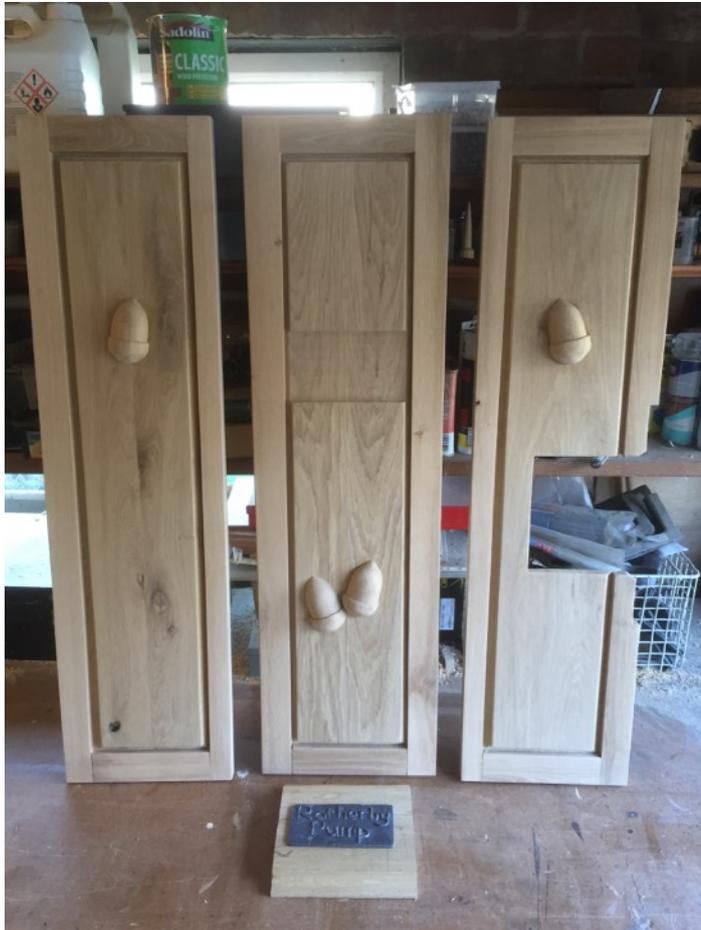
The next stage was to make the wooden case parts. These were made from oak, a mixture of English and French varieties. The basic format being a surrounding frame and central panel. The central panel is slightly smaller than the groove it fits in to allow for expansion as humidity varies throughout the seasons. These panels are glued using a waterproof external PVA glue and pinned with oak pins to prevent joint separation.

Two “acorns” were turned on the wood lathe and then cut in half to make the four adornments as shown in the picture above. These are held in place using PVA glue and brass wood-screws.

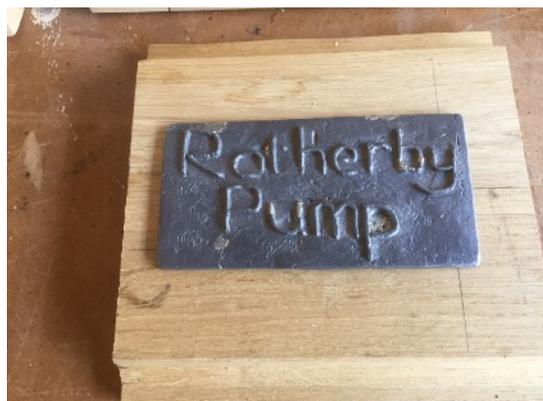
Also visible in the picture above is the lead plaque to go on the front of the case, that being the middle panel in the picture above, in the recess at around two thirds height. This plaque will be bolted in place once the wood has been treated. Details of the plaque are below:

The plaque was made by carving the text (reversed) into a piece of oak, then pouring molten lead onto it, the lead was kept molten until all the mould was filled, using a blowtorch. Once all the mould was filled, the lead was allowed to solidify and cool naturally. The plaque was then given the “once over” with a brass wire brush before being treated with patination oil.
